HydraTite® Internal Joint Seal

Mechanical Trenchless Remediation for Repair of Pipe Joints

Bulk Water Supply November 2025

WaterNSW & Interflow Pty Ltd

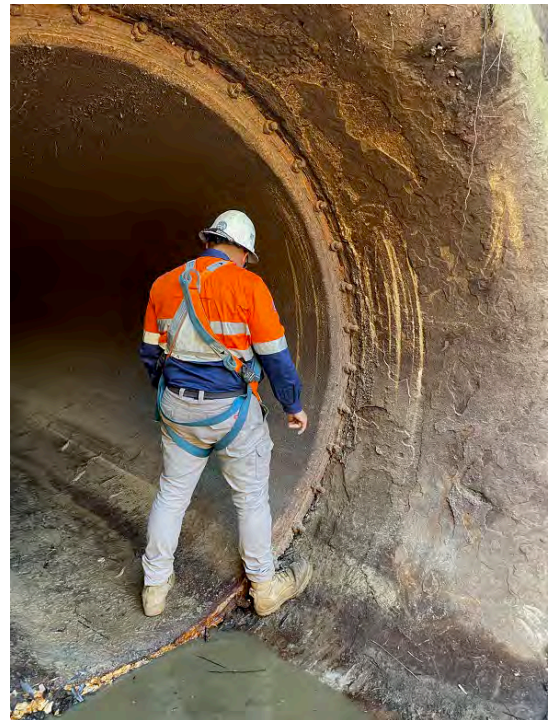
WaterNSW & their specialist repair contractor Interflow Pty Ltd faced a range of challenges which included leaking joints at the interfaces between 2 different shapes (open channels transitioning into pipes at river crossings), differing expansion and contraction due to dissimilar pipe & channel materials and a limited window of time during which the system could be offline to install the seals.

While the channels are concrete, the pipes crossing the creeks & rivers are ductile iron and the expansion and contraction of dissimilar materials has been an ongoing source of leaks at the joints which range from approximately 2100 to 2400mm diameter at different locations in the network.

The deteriorated condition of the concrete channel and headwall added to the complexity of the problem.

Figure 1 Inspection of Joint before HydraTite installation, April 2023

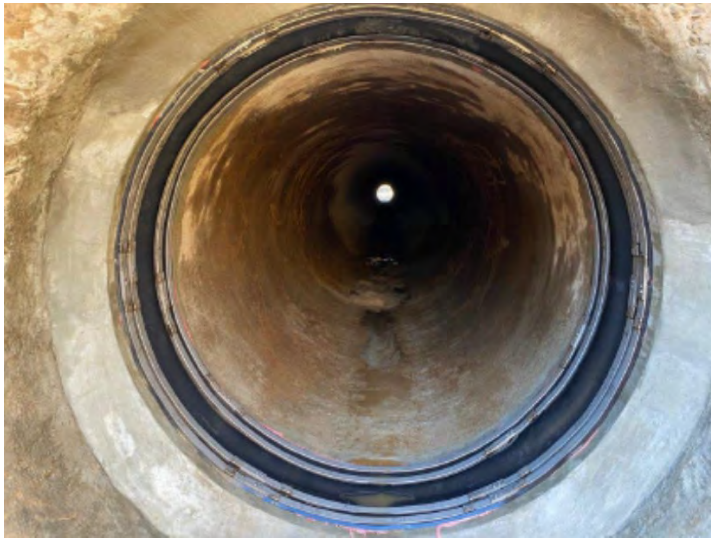
Figure 2 April 2023 Completed Job, Photo Courtesy of Interflow

With the original installation in April 2023 (see Figure 2) demonstrating the suitability and success of HydraTite® to seal the leaks, WaterNSW approved the use of the HydraTite® Seals for an additional 6 creek crossings in the network with installation conducted during a scheduled maintenance shutdown in late 2025.

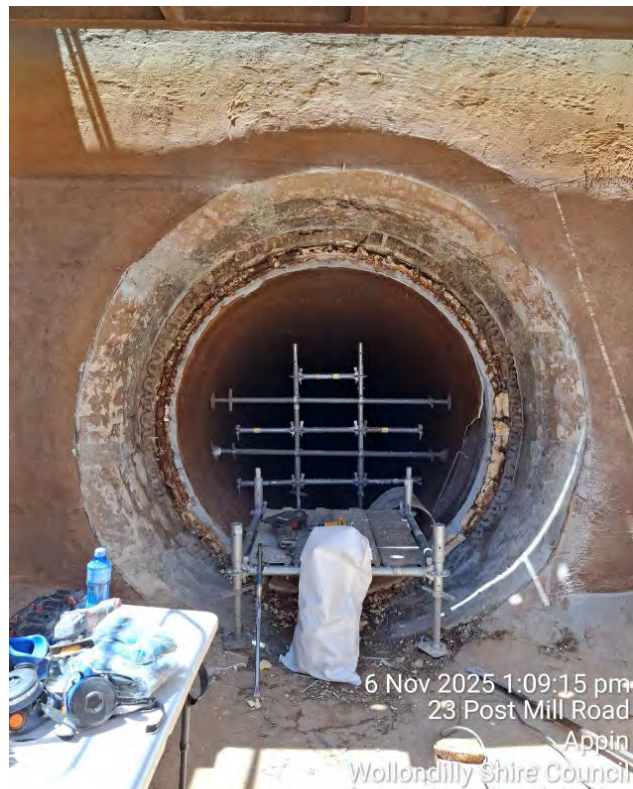
Figure 3 Surface preparation Nov 2025
Photo Courtesy of Interflow

Preparation (see Figure 3) included removal of old & degraded material and concrete to achieve a solid substrate. A suitable mortar was then used to reprofile and buildup the channel and headwall creating a platform for the HydraTite® to seal between the pipe and open channel.

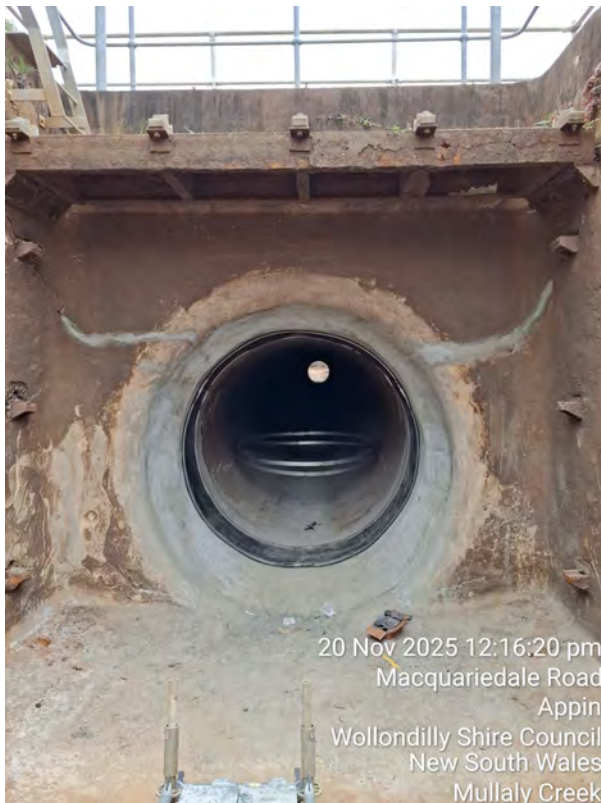
20 Nov 2025 12:16:20 pm
Macquariedale Road
Appin
Wollondilly Shire Council
New South Wales
Mullaly Creek
Figure 4 HydraTite Joint Seal partially installed, Nov 2025
Photo Courtesy of Interflow

After reprofiling the deteriorated channel and headwall, a Double Wide EPDM rubber seal (approx. 2100-2400mm diameter, sized for the specific location) was installed, with 2 stainless steel retaining bands positioned (one in the smaller diameter pipe and the second on the larger diameter profiled section) to locate the EPDM rubber seal in the correct position as shown in figures 4 & 5.

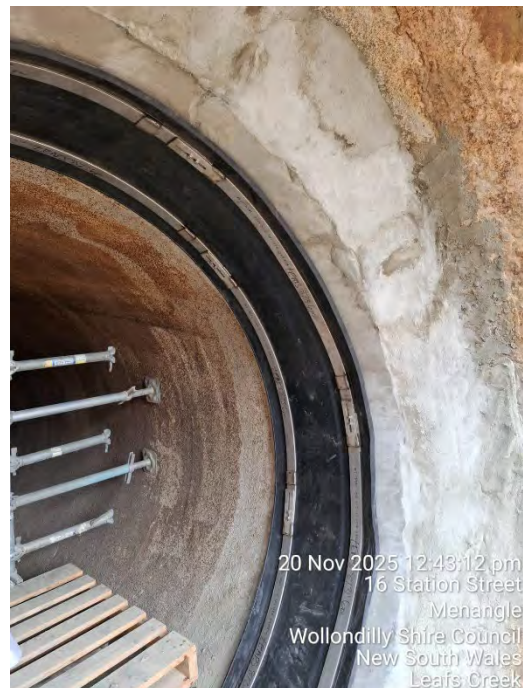
20 Nov 2025 12:43:12 pm
16 Station Street
Menangle
Wollondilly Shire Council
New South Wales
Leafs Creek
Figure 5 Closeup of HydraTite Seal partially installed
Nov 2025 Photo Courtesy of Interflow

With the correct positioning of the seal and retaining bands confirmed, the third and fourth stainless steel retaining bands were positioned and all retaining bands expanded to finalise the installation as shown in figure 5.

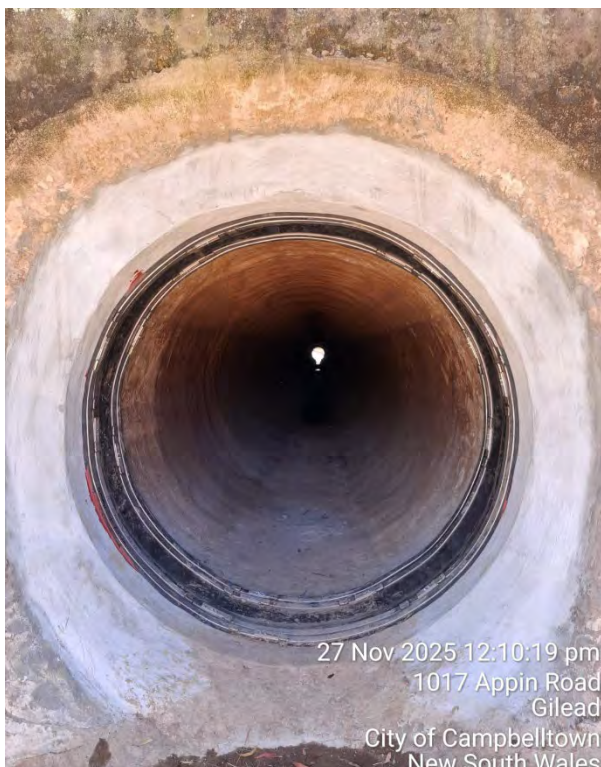
27 Nov 2025 12:10:19 pm
1017 Appin Road
Gilead
City of Campbelltown
New South Wales
Figure 6 HydraTite Seal installation complete Nov 2025
Photo Courtesy of Interflow

The end result was all 6 additional HydraTite® Joint Seals successfully installed and the system recommissioned.
