HydraTite® Internal Joint Seal Saves Bison on Ranch!

Private, Livestock – Bison Ranch

McCall River Ranch of Idaho

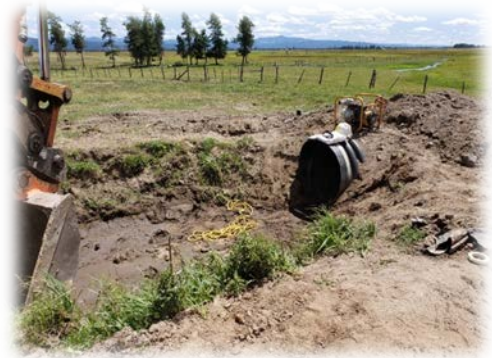
HydraTech's factory technicians installed the HydraTite seals in a matter of a few days. The 45 Degree bend within the pipe made the access of repair locations difficult for the HydraTech installers, yet their specialization in confined space allowed them to complete the job successfully. Custom band size and multi-piece configurations were engineered and manufactured for this project in order for seal installation to be completed beyond and around the 45-degree bend.

The proposed solution involved sealing leaking pipe joints of the ADS irrigation pipe. HydraTech suggested sealing of pipe joints with the HydraTite Internal Joint Seal. The HydraTite is a cost effective and fast solution to repairing leaking joints and points of underground pipe.
