## PRODUCT TESTING REPORT

**Subject:** CRETEX PRO-RING™ POLYMERIC MAKE-UP RINGS  
**Prepared For:** INDEPENDENT SEWER CONSULTING SERVICES PTY LTD  
**Address:** UNIT 13/1 ADEPT LANE BANKSTOWN NSW 2200  
**Attention:** DENNIS BENTINK  
**PO Number:** P19008  
**Identification:** PRO-RING™ SEGMENTS 36-24G-600 AND 36-24F-600  
**Specification:** AS 3996: 2019 "Access Covers and Grates" AND WSA-PS 345 "Polymeric Make-up Rings for Sewerage Maintenance Holes"  
**Report Number:** 076953-1  
**Test Personnel:** Chris Vines  
**Date:** 1 November 2019

It was requested that load testing, water tightness testing, gas tightness testing and fatigue load resistance testing be performed on a joined pair of 610 mm clear opening round Cretex Pro-Ring™ make-up rings. The tests were to be performed in order given above then the water and gas tests repeated after fatigue testing was completed.

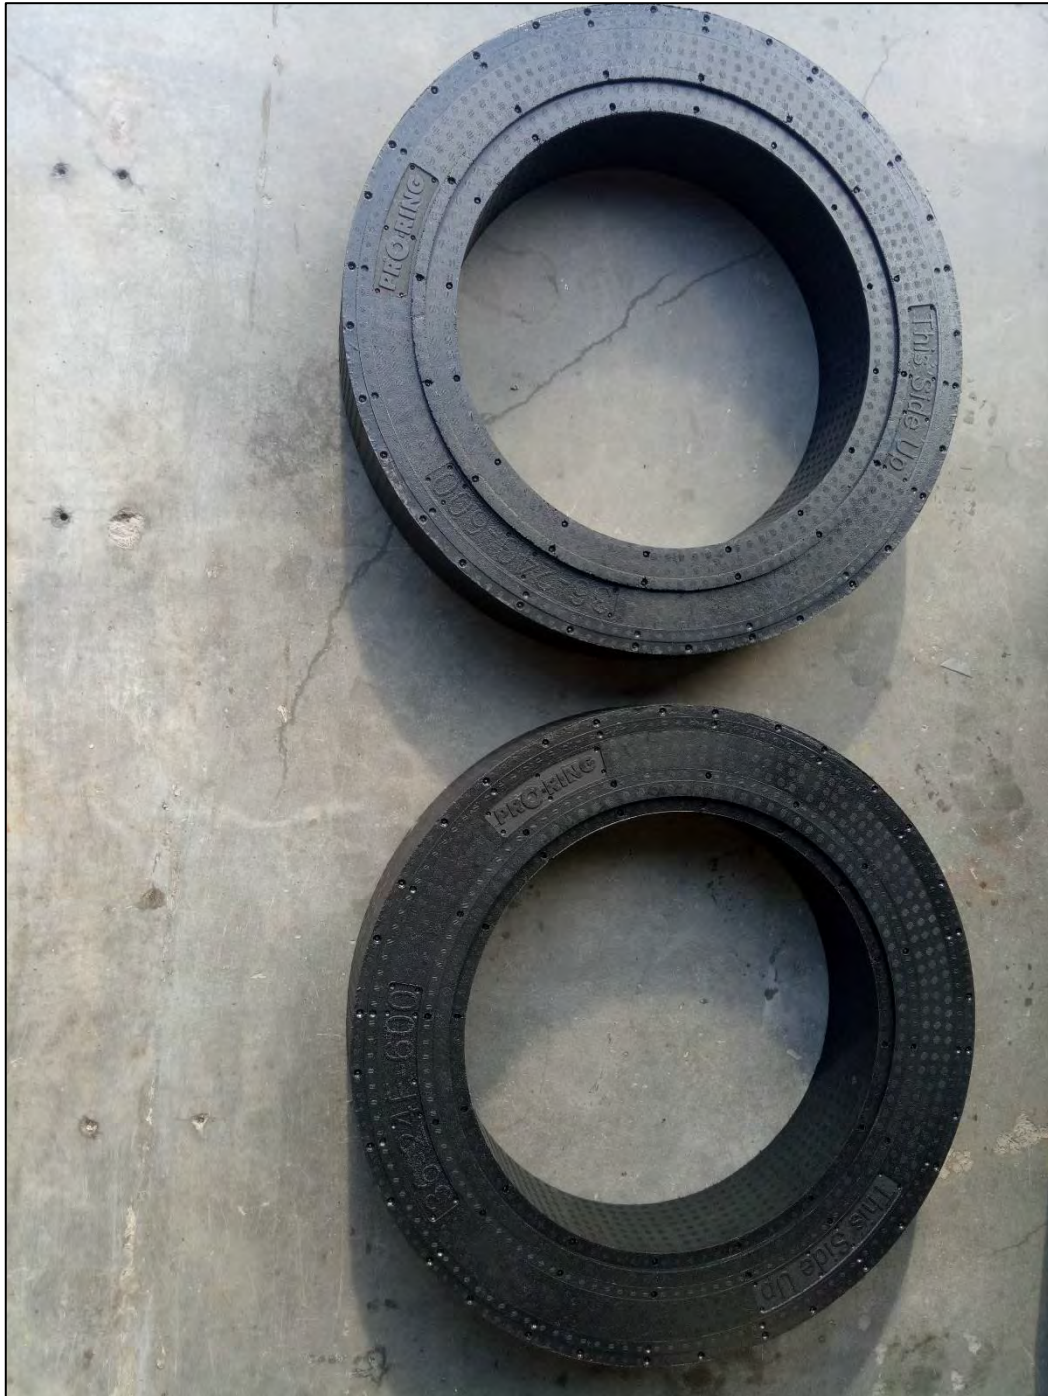
**Figure: 1**  
**Subject: Cretex Pro-Ring™ make-up rings submitted for testing**

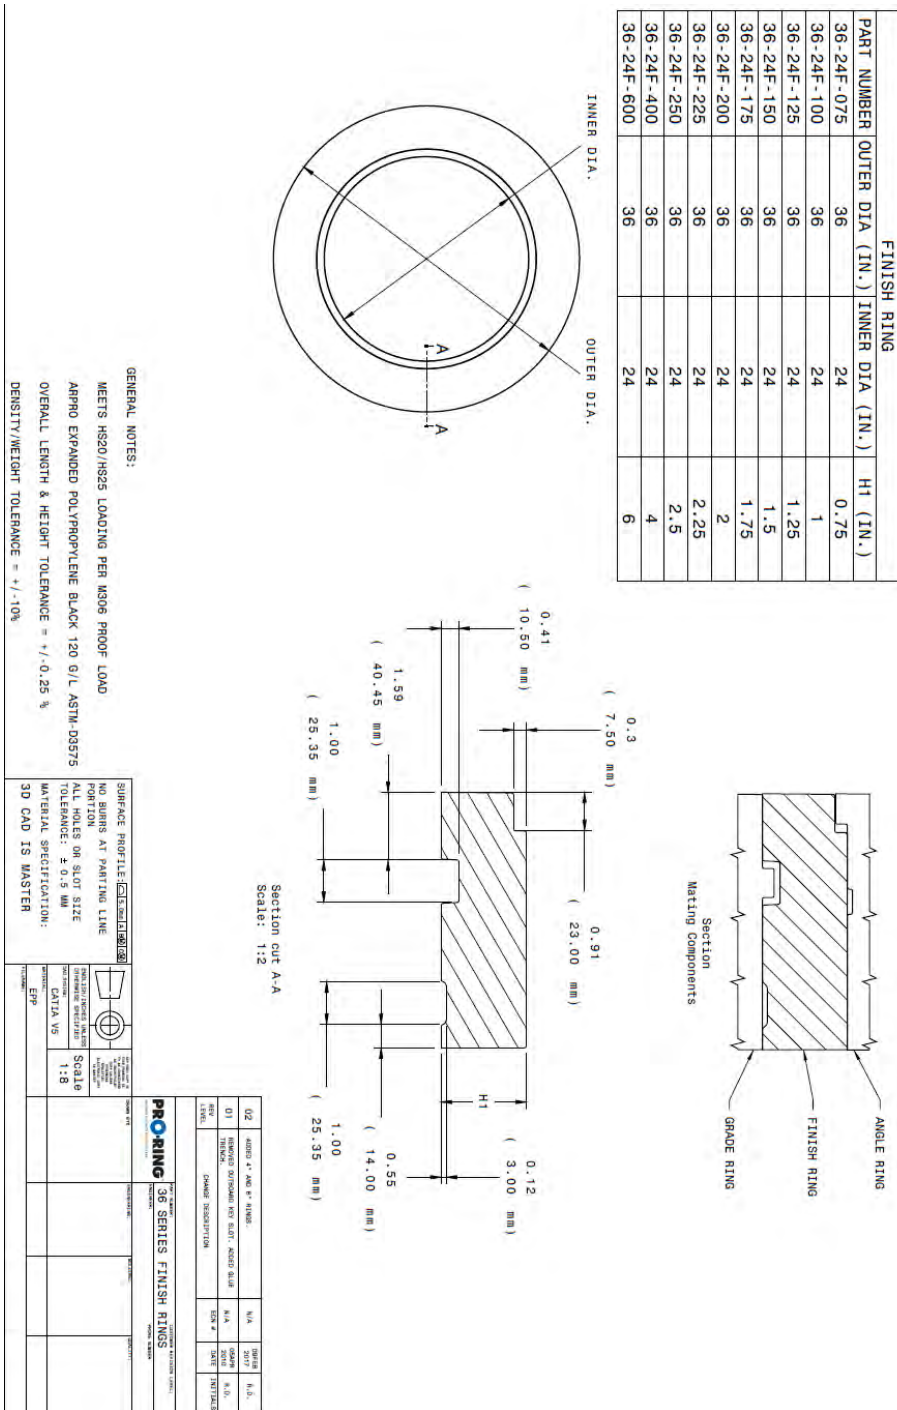
Figure: 2  
 Subject: Cretex Pro-Ring™ make-up ring submitted for testing

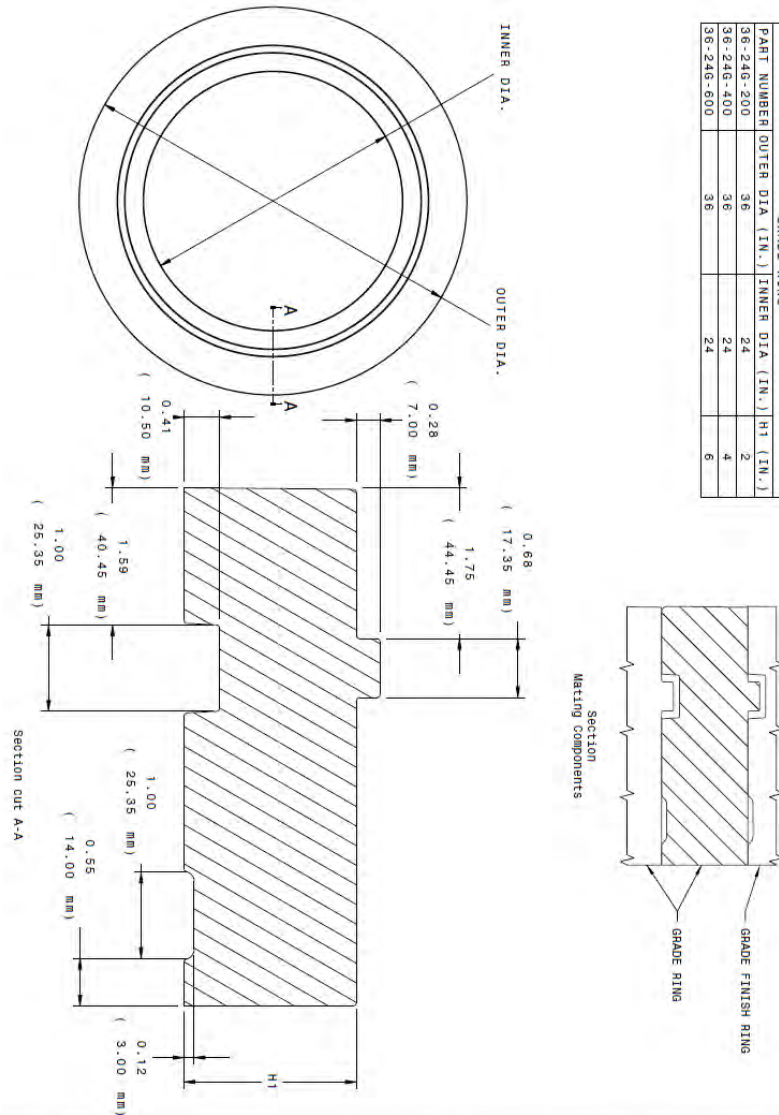
PART NUMBER	OUTER DIA (IN.)	INNER DIA (IN.)	H1 (IN.)
36-24G-200	36	24	2
36-24G-400	36	24	4
36-24G-600	36	24	6

<a href="http://www.cretexseals.com">www.cretexseals.com</a>	
36 SERIES GRADE RING	
LOAD RATING <b>HEAVY DUTY</b>	
MATERIAL SPECIFICATION ARPRO EXPANDED POLYPROPYLENE BLACK 5000 SERIES ASTM-D3575	
LAST REVISED RAD	DATE 05APR2010
© 2010 JSP. All Rights Reserved

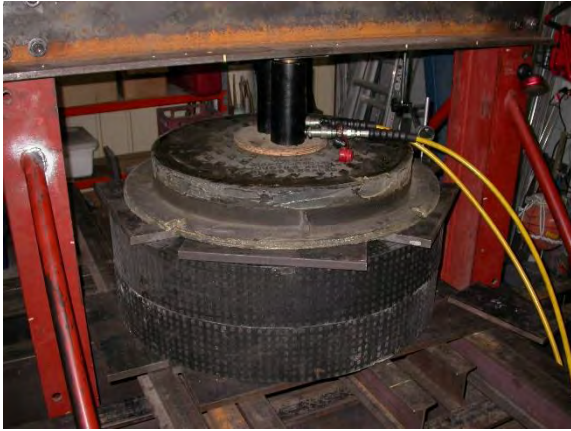
**Figure: 4**  
**Subject: Ring assembly load test**

The test load equal to the ultimate limit state design load was then gradually applied and maintained for a minimum of 30 seconds after which the Pro-Ring™ was assessed for failures.

Test Load:	160 kN (Clause 4.2.2.1(a) for CO > 250 mm, Table 3.1 Serviceability design load for Class D = 1) applied via bearing block to the cover in accordance with Appendix C.
Deflection under load:	13.5 mm (No structural failure observed). Deflection measured in rings only on a 300mm high stack
Acceptance Criteria:	AS 3996: 2019 Class D CO/45 = 610/45 = 13.6 mm (see Table 4.2) Where: CO – circular opening = 610 mm.
Test date:	01/07/2019

Test Load:	5 cycles at 160 kN (see above) applied via bearing block to the cover in accordance with Appendix C
Permanent set:	0.15 mm (No structural failure observed) Deflection measured in rings only on a 300mm high stack
Test date:	01/07/2019

Test Load:	240 kN (Clause 4.2.2.1(a) for CO > 250 mm, Table 3.1 Ultimate Limit state design load for Class D) applied via bearing block to the cover for a minimum of 30 seconds in accordance with Appendix C
Observations:	No structural failures observed in the test unit

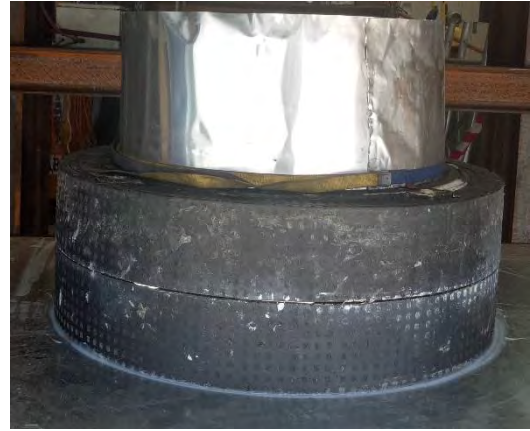
**Figure: 5**  
**Subject: Water tightness assembly**

Sealant used:	Chem Link M1 Adhesive (as supplied by client)
Coating system:	N/A
Water depth:	153mm water (A0986)
Test date:	01/7/2019
Test time:	15 minutes
Observations:	No evidence of leakage in the ring to ring seal

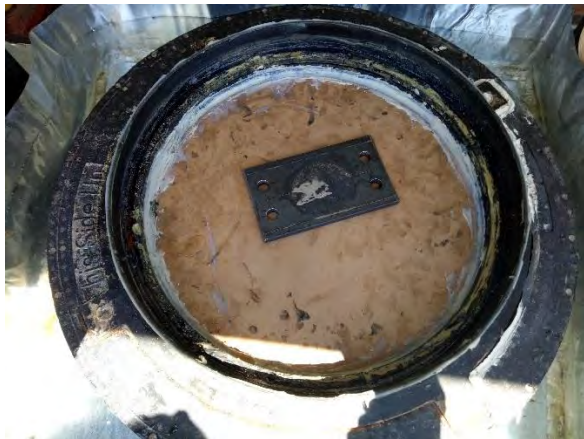
**Figure: 6**  
**Subject: Gas tightness test rig with water external (air filled into chamber under wooden seal insert)**

Sealant used:	Chem link M1 adhesive (as supplied by client)
Coating system:	NA
Test pressure:	0.52 kPa (55mm water in manometer A0986)
Test date:	02/7/2019
Test time:	15 minutes
Observations:	No evidence of leakage in the ring to ring seal

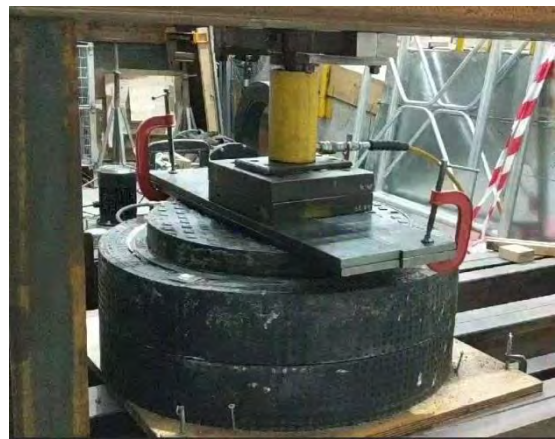
**Figure: 7**  
**Subject: Fatigue rig assembly (after lid cracked)**

Initial fatigue testing was performed using as standard D class drain lid with the normal wooden test block (240 mm square). However, the lid cracked after 50k cycles and no replacement was available hence the steel plates were installed to continue testing of the rings by loading directly through the rim rather than via the lid.
